UNI-3262

April 17, 1986

RIVER DISCHARGE LINES CHARACTERIZATION REPORT

J. F. Beckstrom, J. M. Steffes

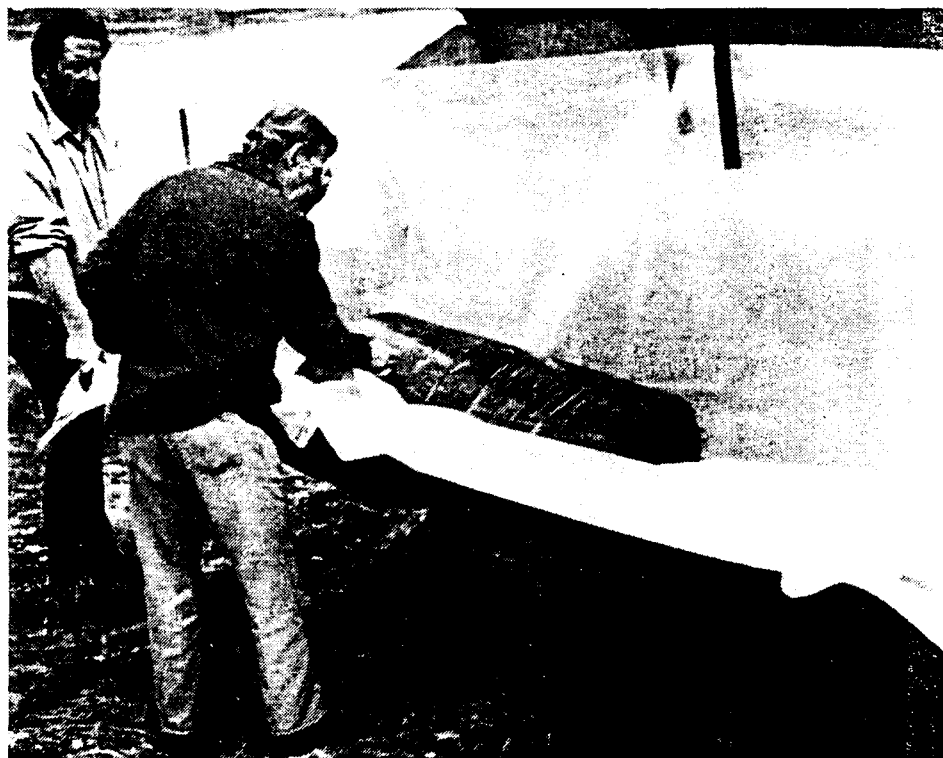
Figure 9. Technical Smears were Taken from Sample Section.

No contamination was found on the exterior surface of any pipe (Figure 8). All identified radioactive material was located on the interior surfaces and in the loose scale (sediment) from inside the inactive pipe. Table 3 lists the instruments used to determine the isotopic concentrations and activities found in the 100-Area river lines. The Model 6700 Multichannel Analyzer's calibration and quality control procedures were conducted in accordance with UNI-M-76 REV1, Effluent Analytical Program. Figure 9 shows the sample section in the front loader as technical smears were taken.

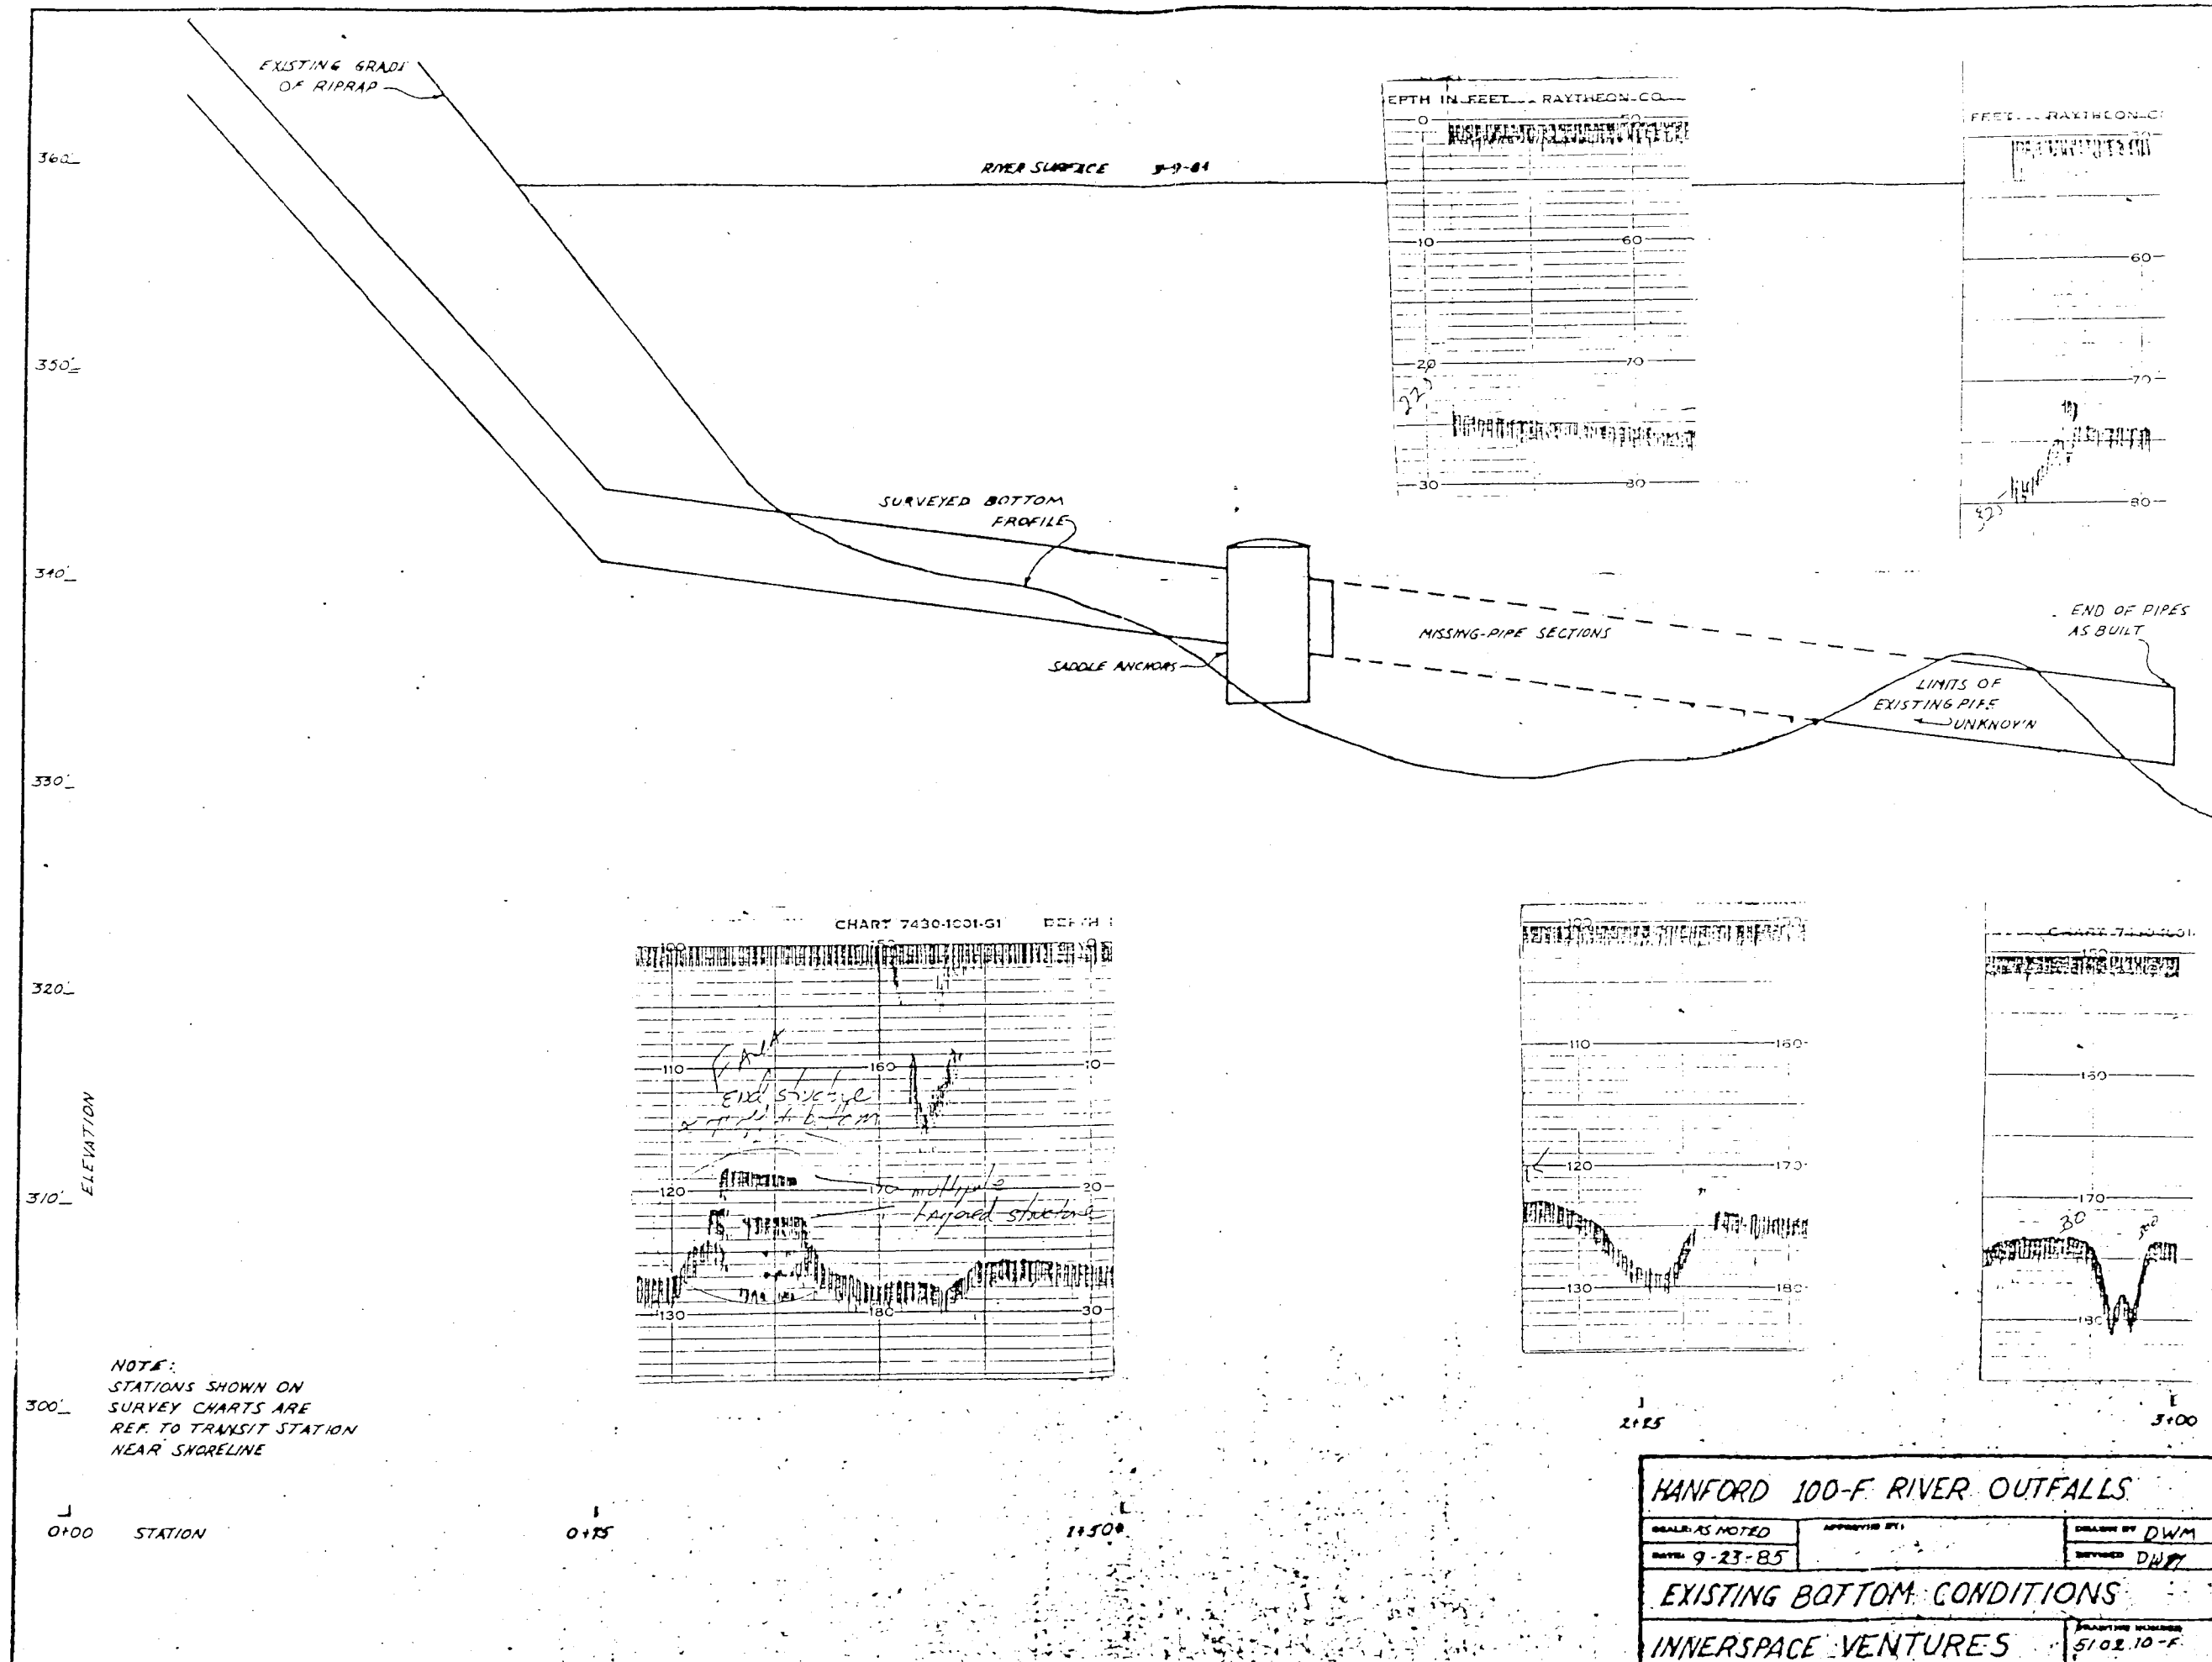
| INNERSPACE VENTURES | | 81.02.10-H |

As a result of these investigations, it was determined that three of the areas had pipelines which were not buried, but in fact, were severely exposed. In the case of the F area discharge lines, they showed disconcerting signs of damages of major proportions. The remaining site had not been exposed and was therefore not readily explorable.

sensing devices, however this type of procedure was outside the scope of this investigation and those electronics necessary were not on site for use. At this point it appears that several sections of both pipelines have become dislodged and carried away downstream. The exact extent of the break in continuity cannot be determined at this time. This is in part due to the detection equipment requires a continuous pipeline to act as a R.F. radiating antenna, and partially due to the extreme current velocities. The minimum amount of missing line, as observed by the divers, is 50 LF with a maximum of 125 LF.

1. The F area pipelines are completely exposed to the force of the river flow and the stresses induced by that flow. Either these stresses or other induced forces have dislodged both pipelines from their foundations and carried away several sections of each pipeline.

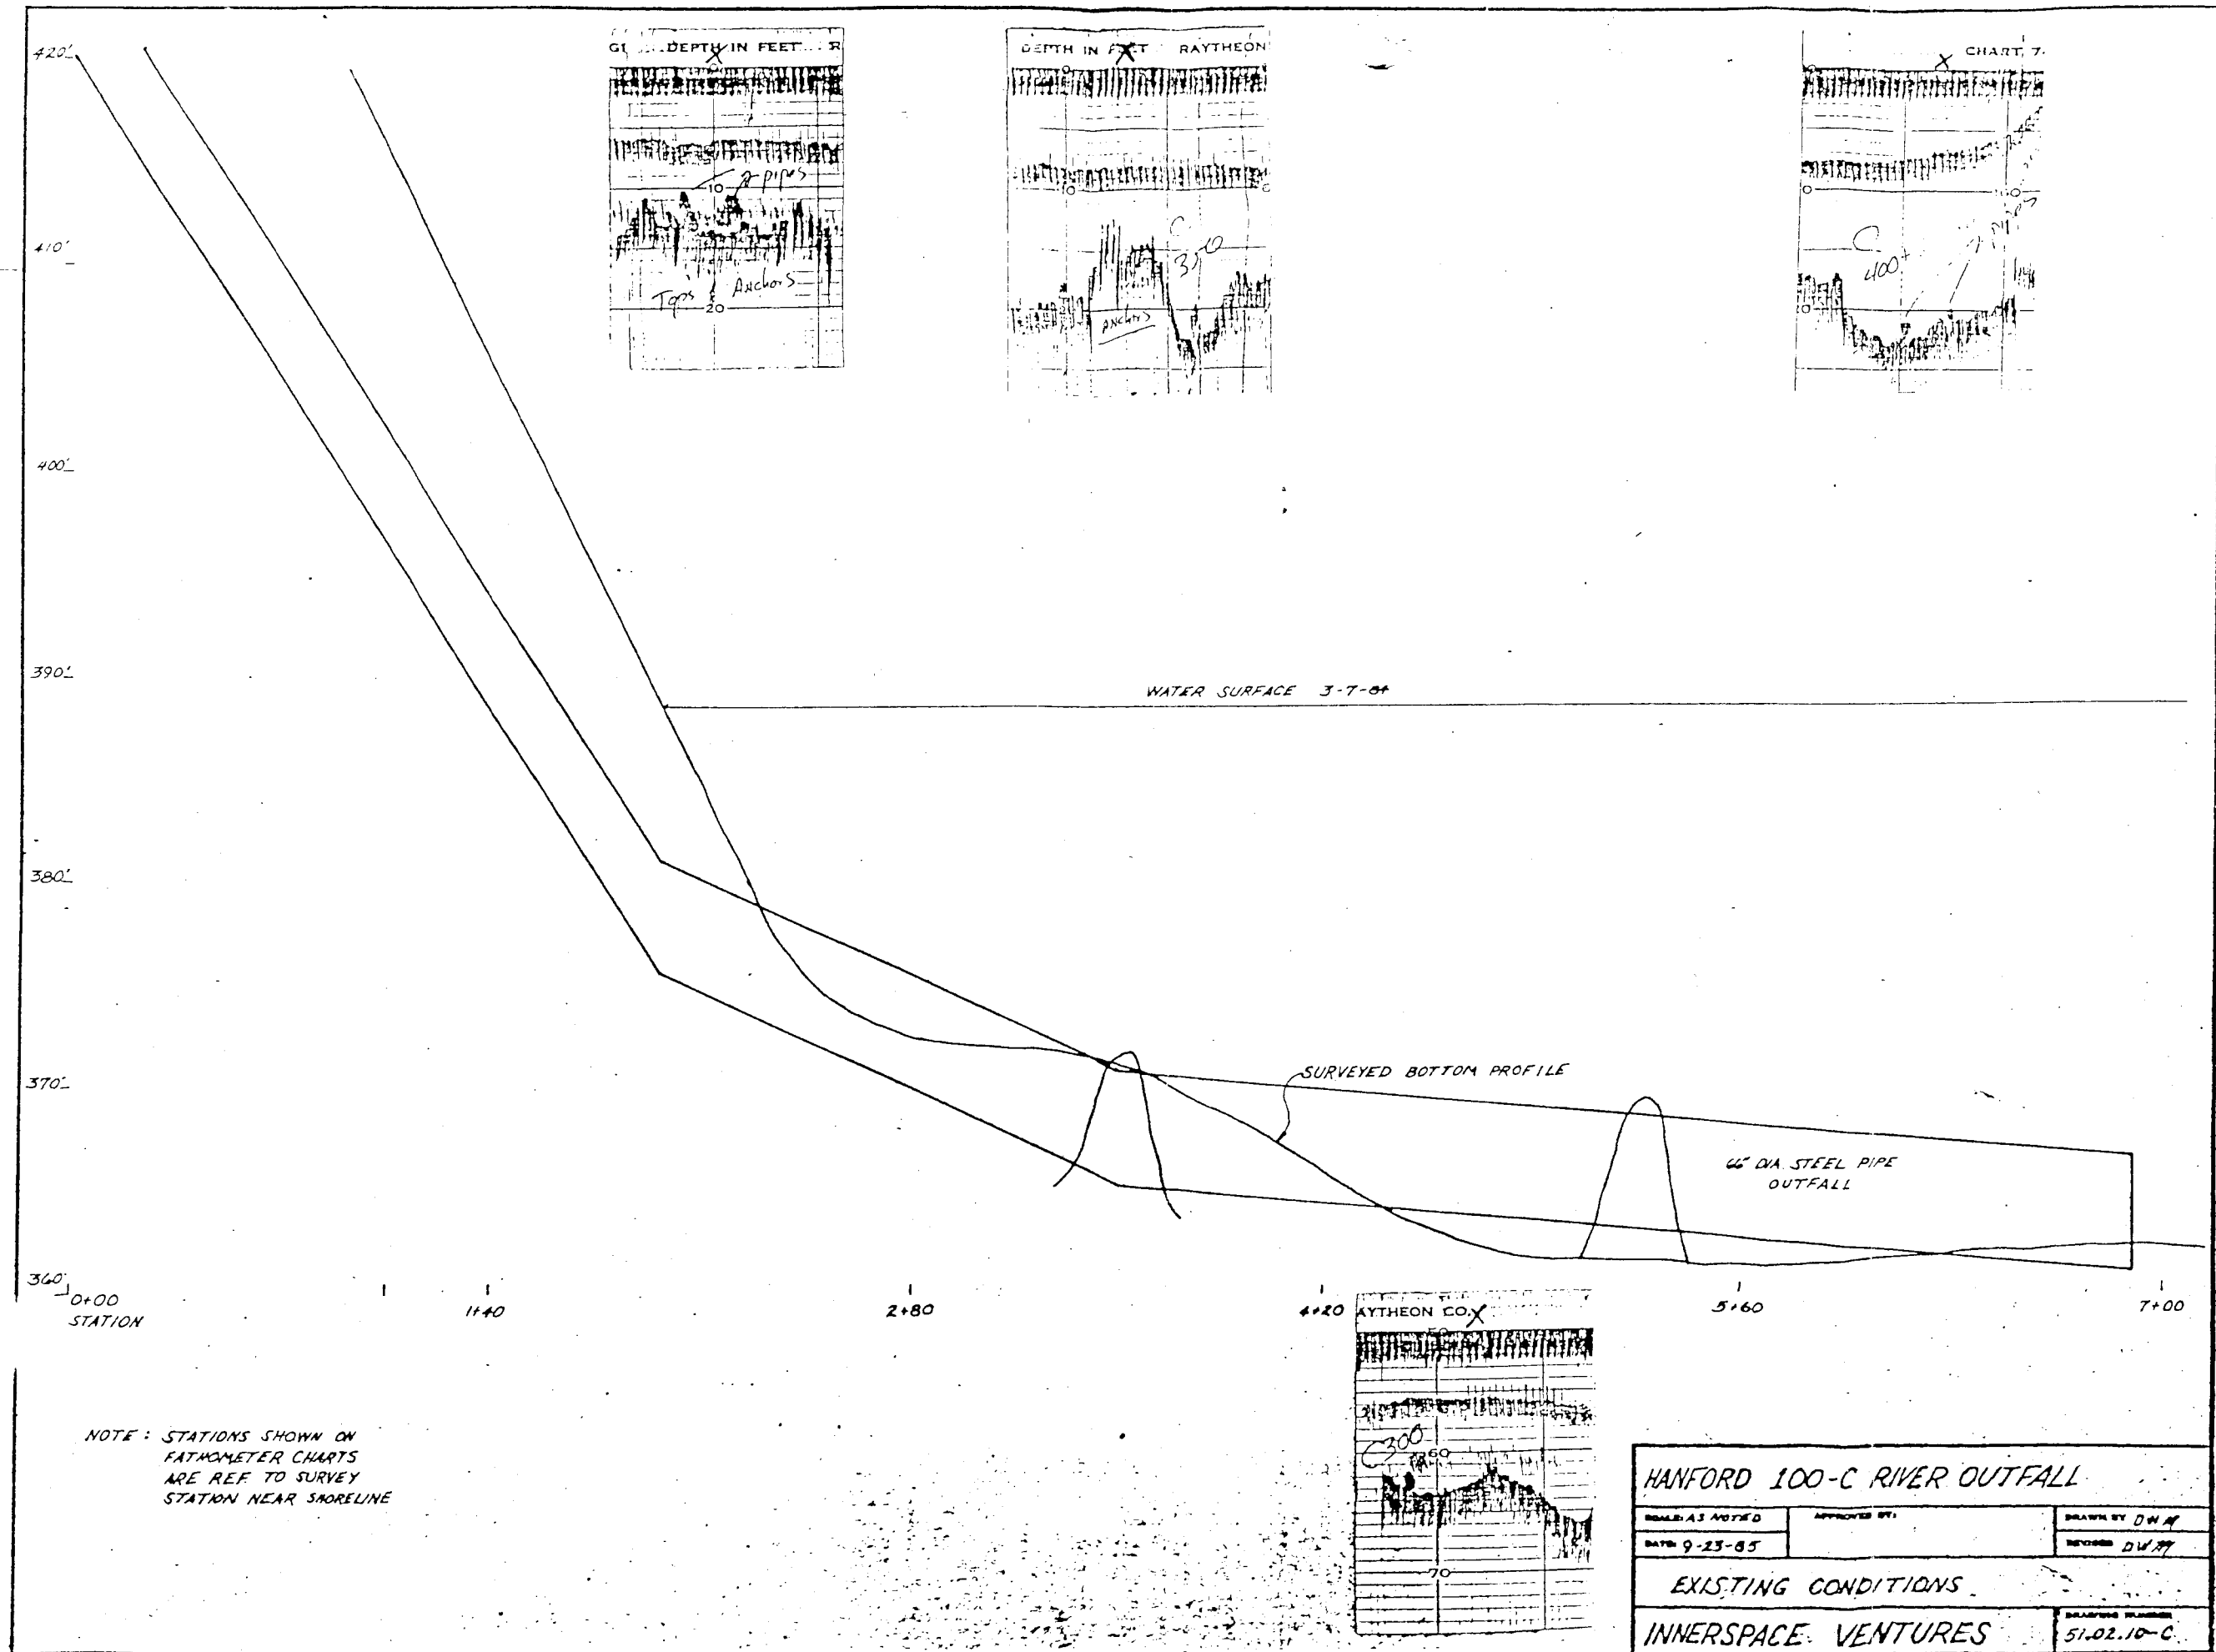
| INNERSPACE VENTURES | | DRAWING NUMBER: 51.02.10-0A |

Details of the bathometric surveys and profiles of the existing bottom conditions are included in appendix "A" in a more visual format.
